SECRET			25 X 1
	(c) NATI	ONAL PHOTOGRAPHIC INTERPRE	TATION CENTER	l	
	Page1_ of _1		Attachment to	Z-12021/84 NPIC/PEG (11/8 2-PART GRAPHIC	34) C
		SILO HEADWORKS DESTRUCT KOSTROMA SSM COMPLEX, U.	SSR		25X1

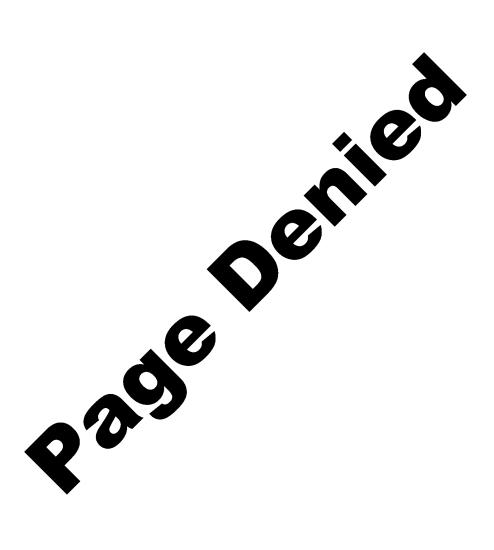
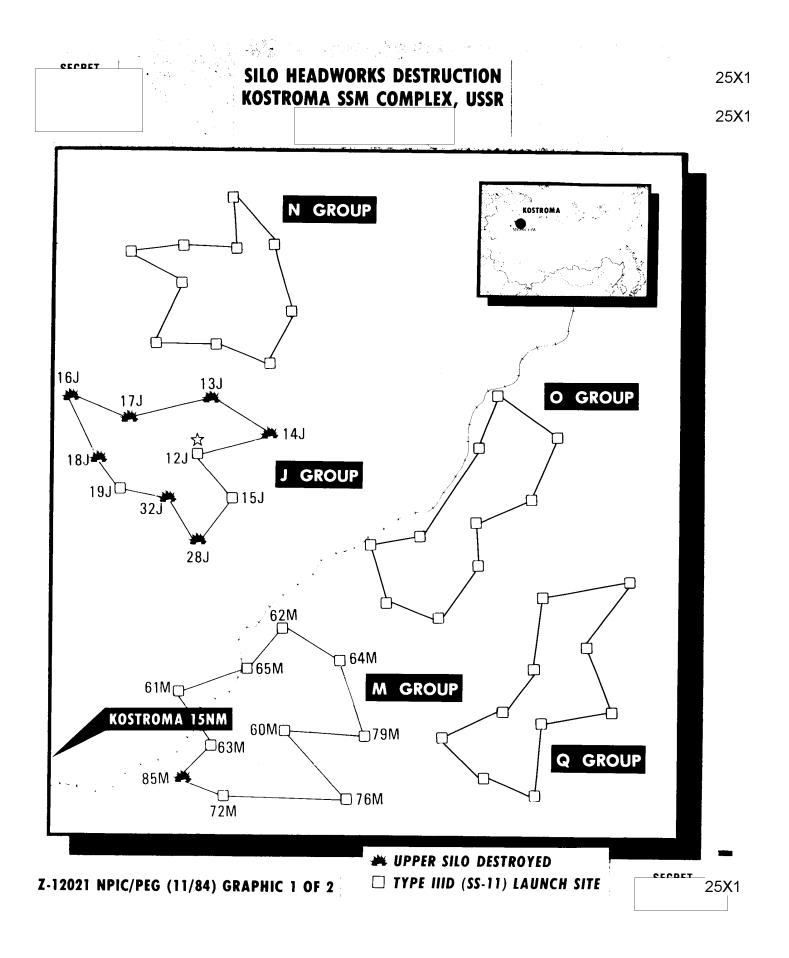
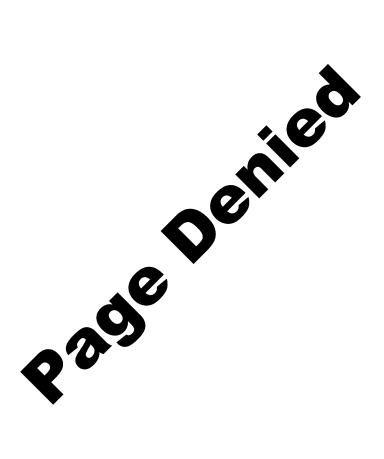
1.	AT THE KOSTROMA	THE UPPER SILO OF THREE ASSM COMPLEX HAVE BEEN DESERVED FOR THE FIRST TIME SWN)	STROYED. DE	STRUCTION	
2.	THE UPPER SILO	STROMA ICBM LAUNCH SITE 8 AREA HAS BEEN CRATERED.	A PROBABLE S	ILO DOOR	25 X 1
	CRATER (GRAPHIC LAUNCH SITE 17 ALSO BEEN CRATER TO BE WITHIN THE SITE SECURITY BUT TO BE TO BE SECURITY BUT TO BE TO BE SECURITY BUT TO BE	EADWORKS, AND THE SILO SHA 2). AT LAUNCH SITE 16 () THE INTERPOLATION OF THE INTERPOLATION OF THE INTERPOLATION OF THE SITES.	J) (UPPER SILO AI PAVING BLOCI ARE OBSERVEI ND NO TEMPORA	AND REAS HAVE KS APPEAR D. THE	25X1 25X1
	ONE IN THE M GROUPPER SILO DESTI	SS-11 LAUNCH SITES (SEVEN DUP) AT KOSTROMA HAVE NOW ROYED. IT CANNOT BE CONFI ITES WILL BE DESTROYED.	BEEN OBSERVI IRMED AT THIS	ED WITH THE
